BEHAVIOR OF FORGED S-816 TURBINE BLADES IN STEADY-STATE  
OPERATION OF J33-9 TURBOJET ENGINE WITH STRESS-RUPTURE  
AND METALLOGRAPHIC EVALUATIONS

By F. B. Garrett, C. A. Gyorgak, and J. W. Weeton

Lewis Flight Propulsion Laboratory  
Cleveland, Ohio

NACA RM E52L17

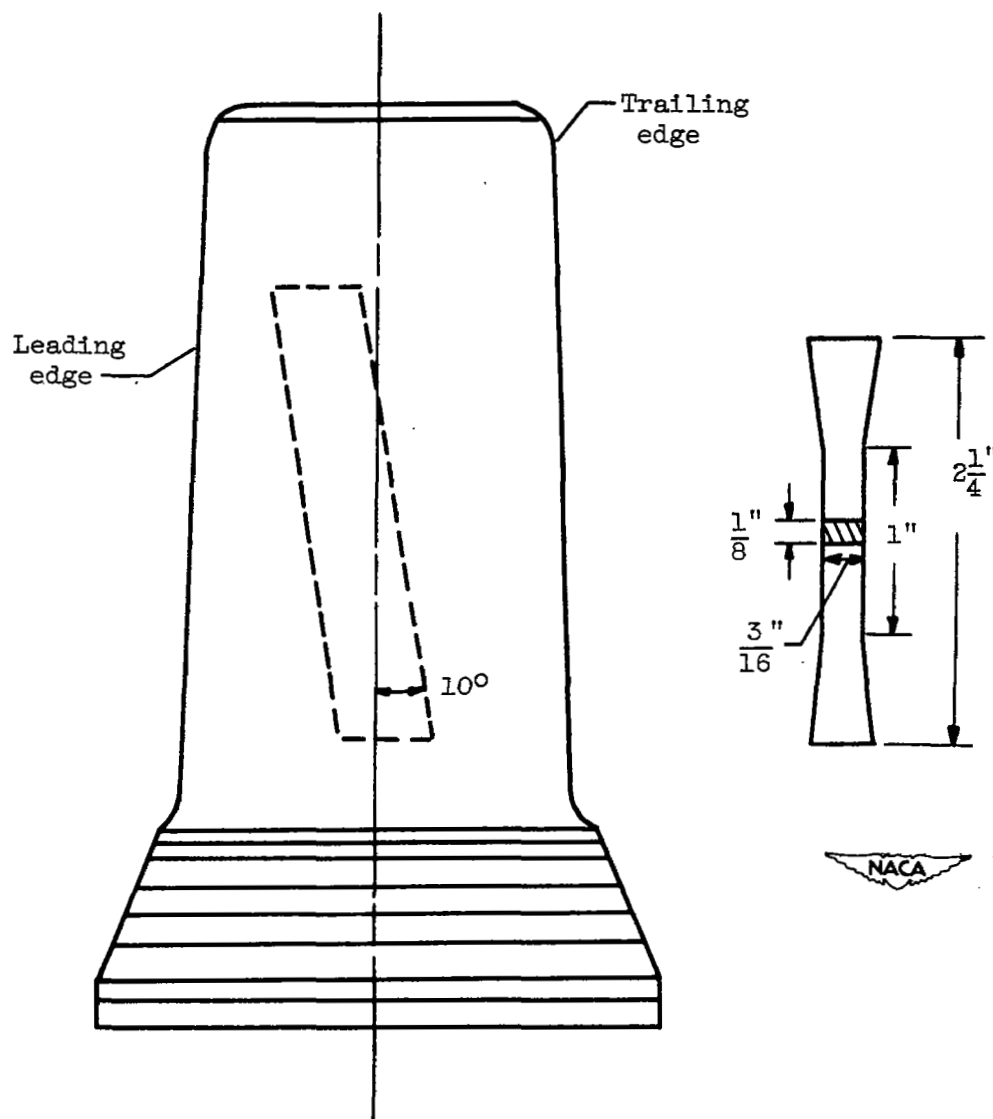
Figure 1. - Blade stress-rupture specimen and zone from which it was machined.

Stress-rupture strengths and other physical properties of blade airfoils. - Test specimens of rectangular cross section (1/8 by 3/16 in.) were machined from the airfoil portions of several blades. The shape of the specimen and the zone from which it was machined are shown in figure 1. Stress-rupture tests were run at 1500° F at various stresses; however, the majority of data were obtained at 20,000 pounds per square inch. Specimen temperatures were so controlled that there was less than a 5° F variation along the length of the specimen with the average temperature varying only  $\pm 5^\circ$  F. Total elongation measurements were made after testing, and hardness measurements were made before testing.

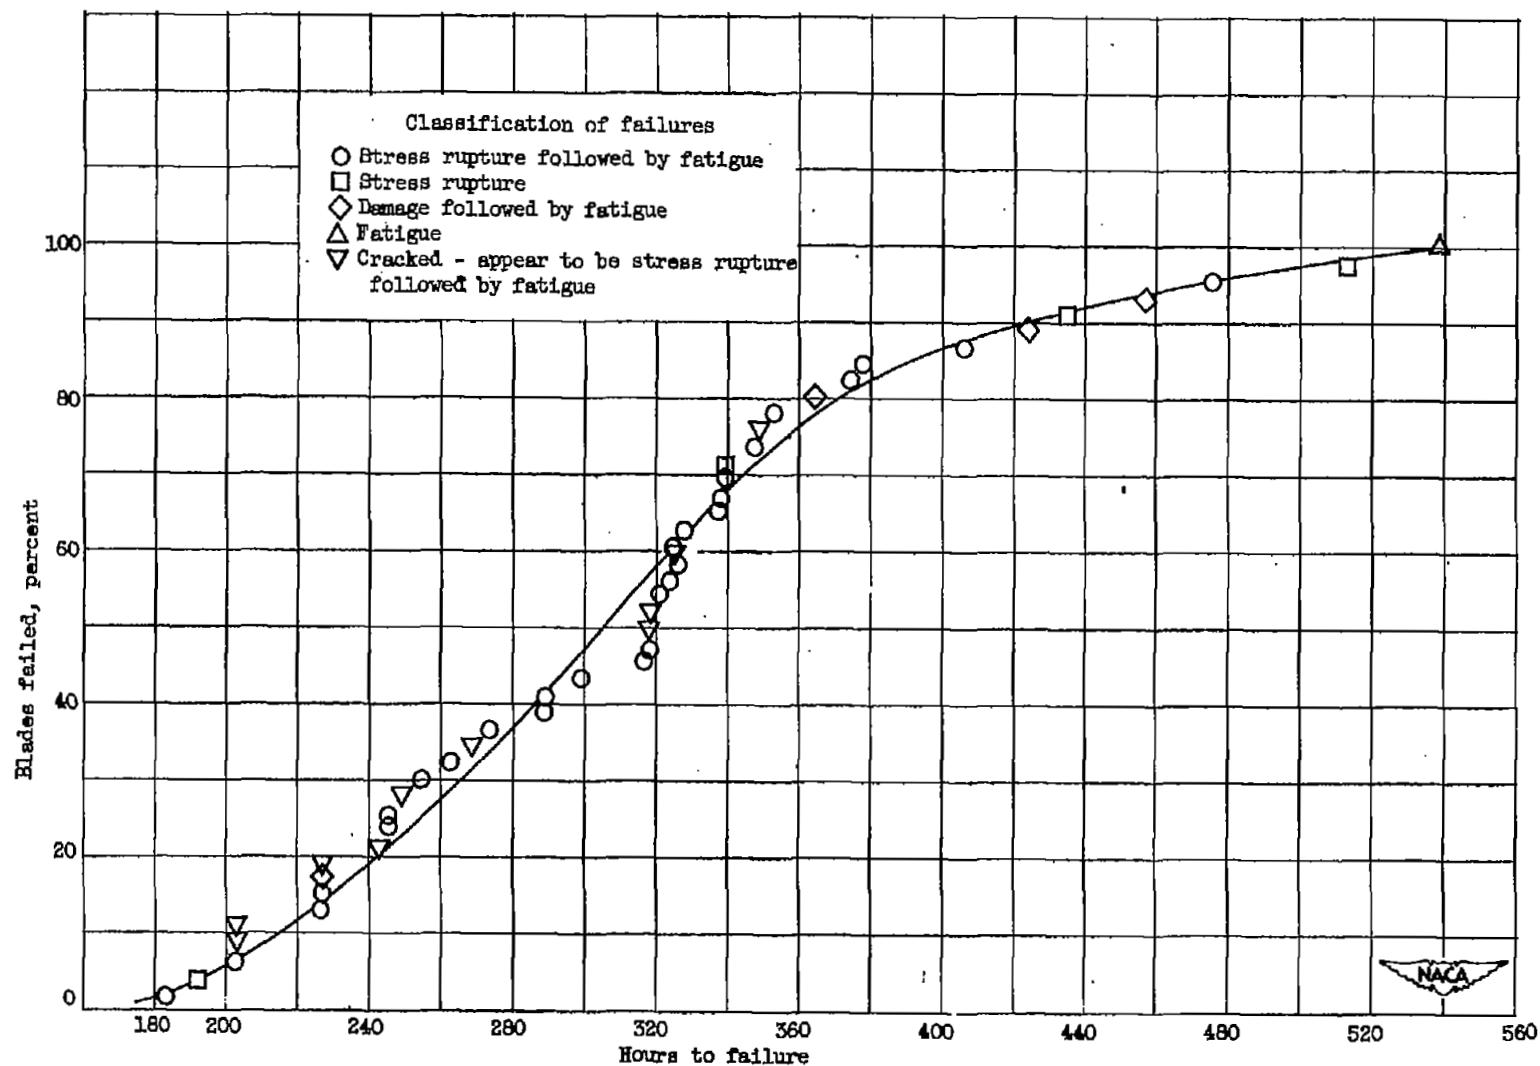
Figure 2. - Performance of forged S-816 blades in steady-state engine operation as shown by cumulative-frequency curve.

Blade failures are plotted on the cumulative-frequency curve shown in figure 2. The first failure occurred in 181 hours, and the last failure in 539 hours, a range of 358 hours.

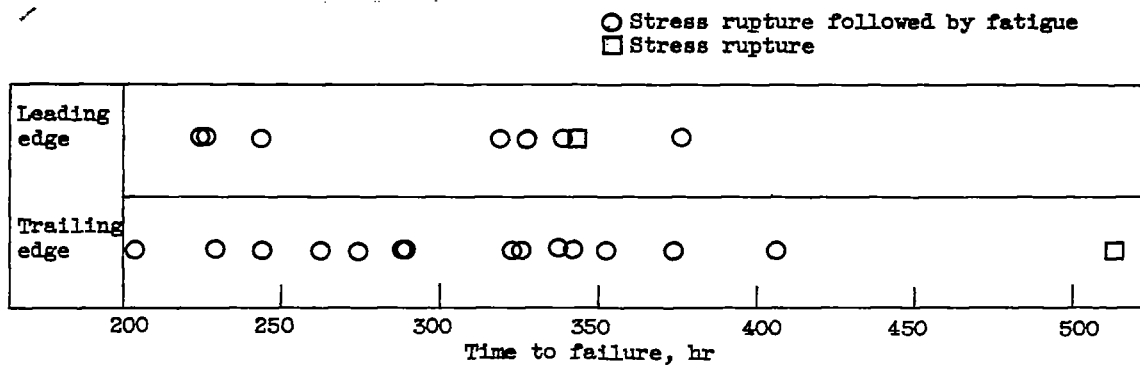
(a) Origin of blade failures

Figure 4. - Failure origins in blades.

4. Of the blades that failed in the engine, 23 were selected for macro-examination; 65 percent of the failures originated at the trailing edges, 35 percent originated at the leading edges, and 74 percent of the failure origins occurred in a zone between 2 to  $2\frac{3}{8}$  inches from the blade roots. The average distance from the roots to the failure edges was found to be 2.11 inches.

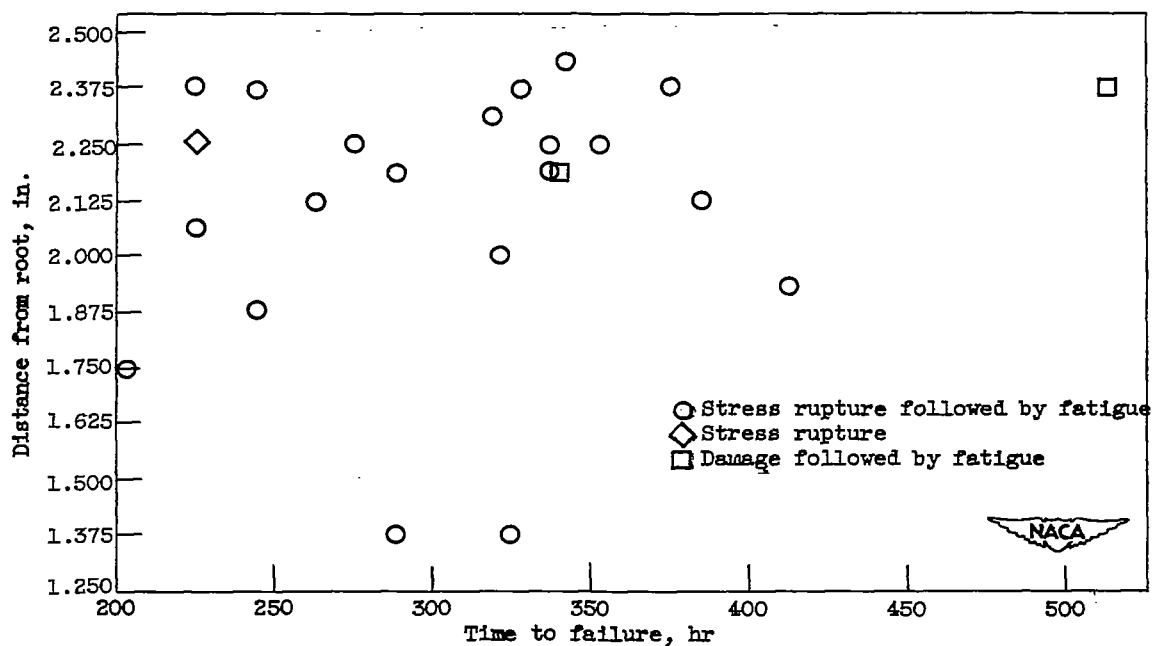
(b) Origin of fracture edges relative to blade roots.

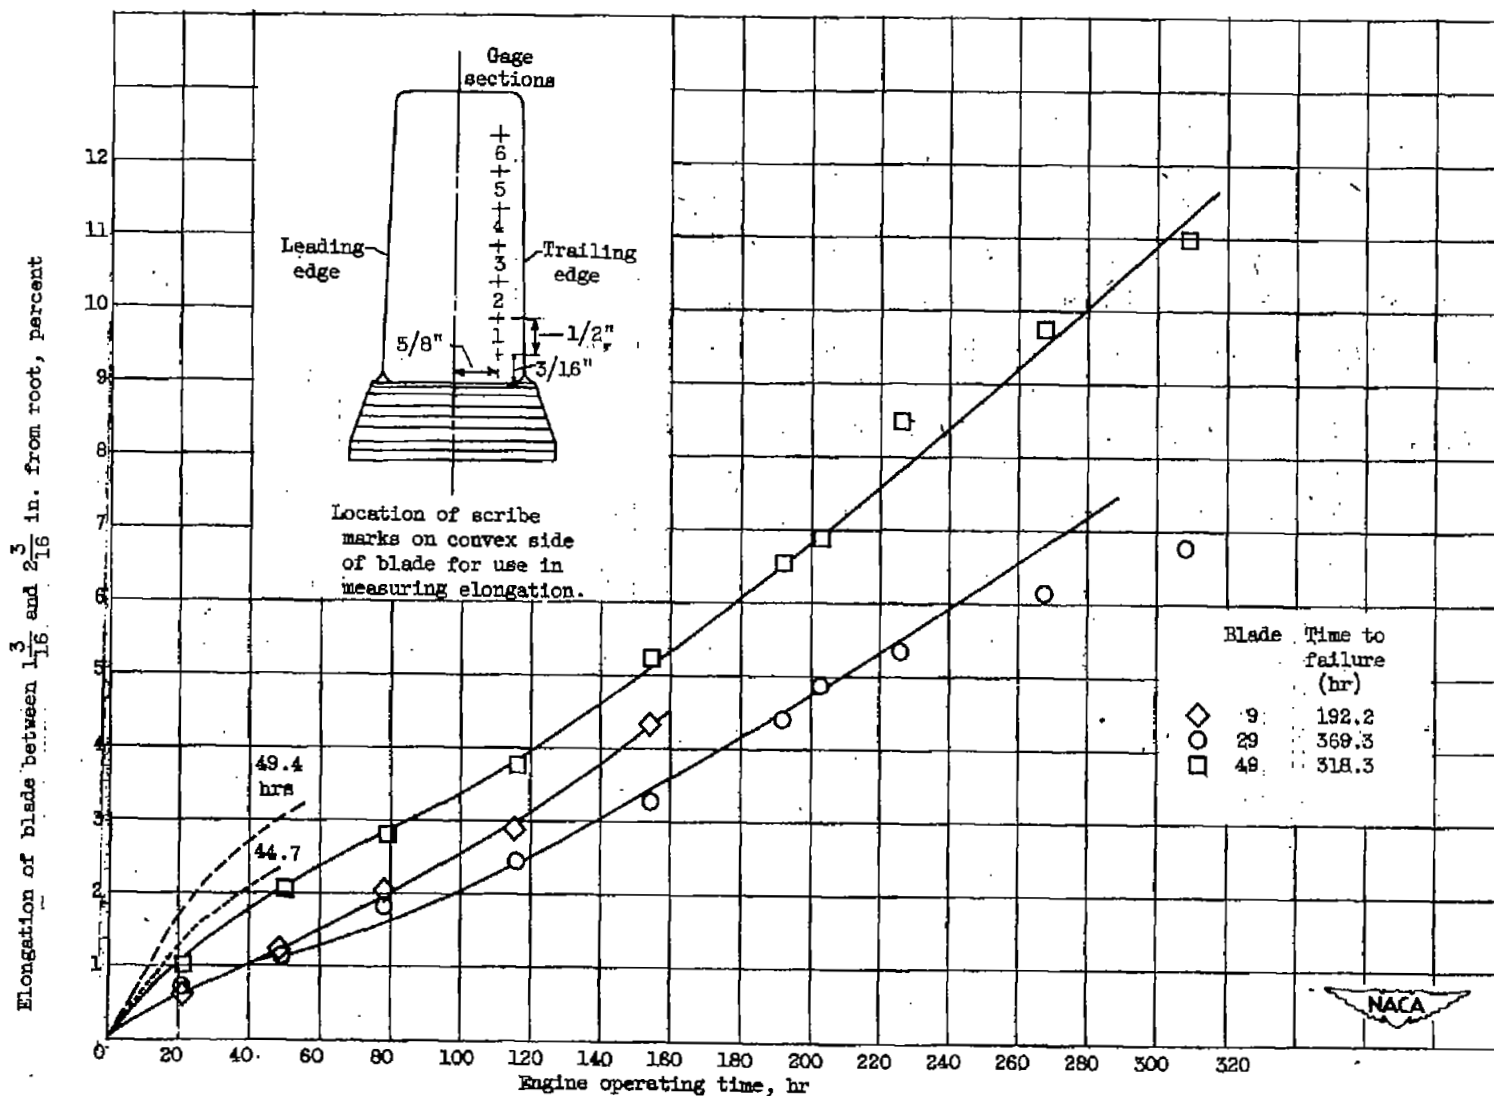
Figure 5. - Elongation of portions of blades during engine operation (gage sections 3 and 4). Dashed curves represent forged S-816 blades from reference 1. (Points shown on curves represent inspection periods.)

The solid curves of figure 5 show the elongation of three blades in the portion of the airfoil between  $1\frac{3}{16}$  to  $2\frac{3}{16}$  inches from the root; the dashed curves are similar data taken from reference 1. The blades of reference 1 were run in cyclic tests and failed in 44.7 and 49.4 hours. It is readily seen that the creep rates of the blades being investigated are lower than those of the previously investigated blades.

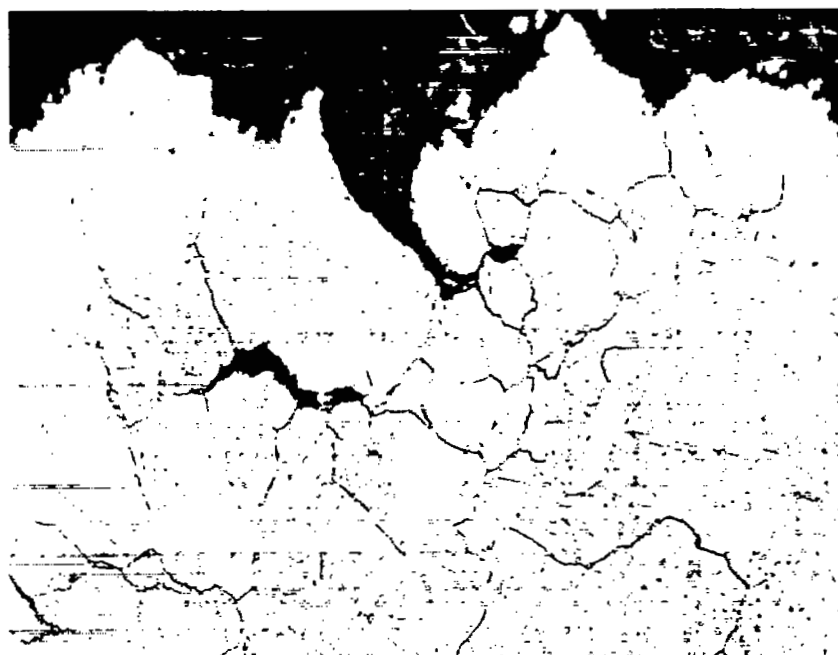
(a) Microstructure near trailing edge of blade.

(b) Microstructure of area in center of blade.

Figure 6. - Microstructural differences in blades that failed in shortest time. (Failure time, 181.2 hr.) Etchant, 10 percent HCl; electrolytic; X250.

Grain size. - The specimens examined metallographically are listed in table I along with grain-size measurements. The blade that failed in the shortest time (181.2 hr) had a variable grain size near the fracture edge (fig. 6). The grain size in the immediate vicinity of the fracture was coarse near the center of the blade (A.S.T.M. 1-4-7) and fine at the trailing edge (A.S.T.M. 6-7-8). The blade that failed in the second shortest time (192 hr) had only slight differences in grain size while the remaining blades including those that failed in the longest periods were fine grained and relatively uniform in grain size.

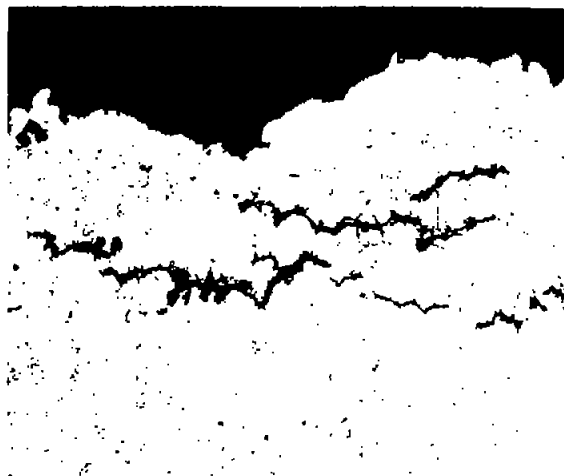
Fracture edge near center of blade 1. Failure time, 181.2 hours; grains coarsest here.

Fracture edge near leading edge of blade 3. Failure time, 254.6 hours.

Figure 7. - Microstructures of fractured or cracked blades at or near areas of failures.  
Etchant, 5 percent aqua regia in water followed by 10 percent hydrochloric acid in ethyl alcohol; both electrolytic.

Metallographic examinations of blade structure. - Photomicrographs showing areas at fracture edges and cracks in blades are presented in figure 7. In addition to the grain-size differences that are evident in figure 8, several other differences in the structures of the blades were observed. For example, the poorest blade (failed in 181 hr) contained more oxide penetrations, particularly at the tip of the trailing edge than did the other blades, (fig 8(c)). Such penetrations may have caused the shorter life relative to the other blades.

The failure zone of the blade that failed in 254 hours originated at the leading edge and, although figure 7 does not show it, there were several microvoids in this locality which may have nucleated the failure. None of the other blades contained such flaws. One of the best blades that was examined metallographically failed by cracking in 434 hours. Only a few intergranular cracks were visible at the trailing edge, although a small segregation of dirt (slag inclusions) and a slag stringer were found near the zone of the crack.

Metallographic examinations of fracture edges of the specimens that failed in 181, 254, and 317 hours confirmed that fatigue cracking took place over a portion of the fracture edges. The blades failed by stress rupture followed by fatigue. Fatigue was indicated by transcrystalline portions of the fracture edges.

Changes in blade microstructure with operating time. - The changes in the microstructure with increasing engine operating time are also shown in figure 7. An increase in carbide precipitation with time, particularly in slip lines and twin boundaries, and the subsequent agglomeration of these carbides appears to have occurred. This tendency is more readily visible in the stress-rupture specimens as will subsequently be described.

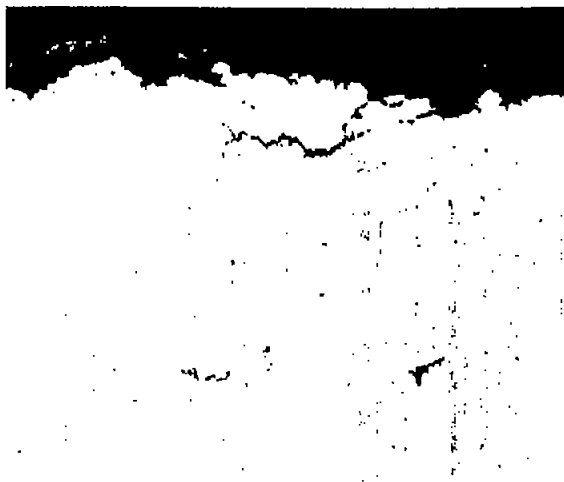
Fracture edge near trailing edge of blade 4. Failure time, 316.7 hours.

Crack near trailing edge of blade 5. Failure time, 434.2 hours.

Figure 7. - Concluded. Microstructures of fractured or cracked blades at or near areas of failures. Etchant, 5 percent aqua regia in water followed by 10 percent hydrochloric acid in ethyl alcohol; both electrolytic.

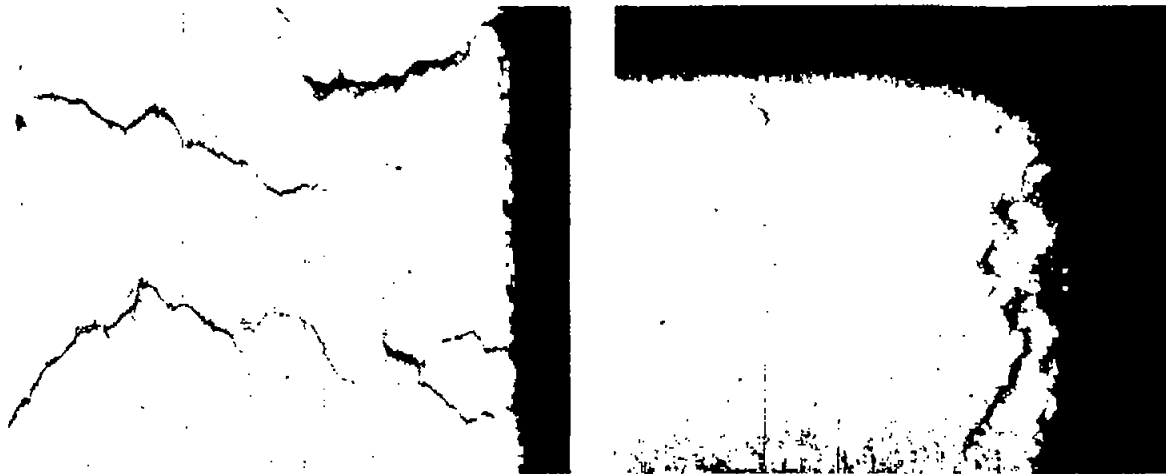
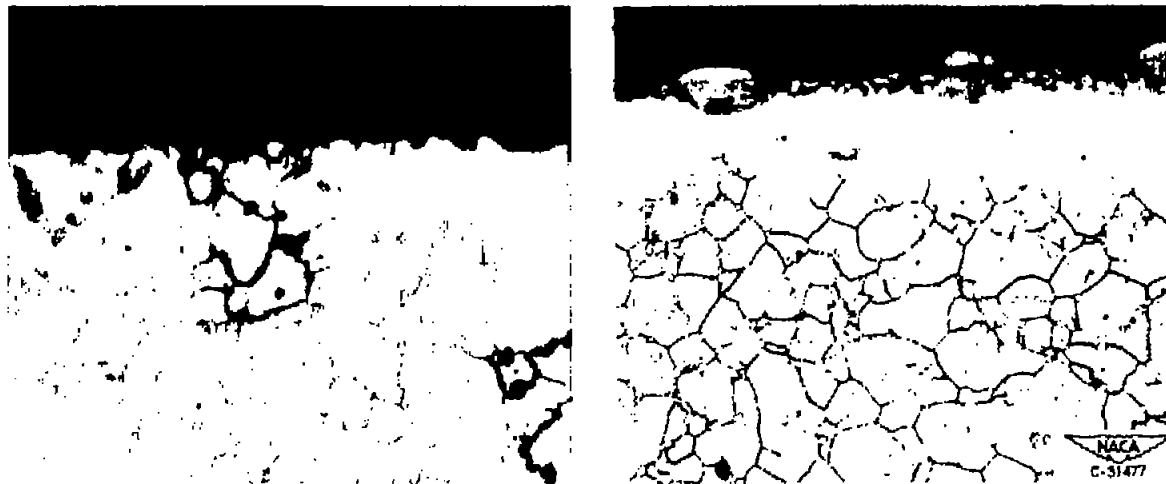
(a) Near fractured edge at center of air foil. X250. (b) Fracture and trailing edges in fine grained, trailing edge portion of blade. X250.

(c) Tip of trailing edge showing oxide penetration. X750. (d) Depletion zone on concave surface, (0.0012 in. deep). X750.

Figure 8. - Surface conditions present in blade that failed in 181.2 hours. Etchant, 10 percent HCl in ethyl alcohol; electrolytic.

The edge conditions shown in figures 8(a) to 8(c) were evident in several of the blades, and the depletion zone shown in figure 8(d) was found in varying degrees in all blade segments examined. Examinations of as-received blades did not reveal this zone which is probably a decarburization zone formed during engine operation. The massive carbides were not visibly disturbed.
